EVALUATION OF ROTMAN LENSES FOR SPACE-BASED RADAR

DEFENCE RESEARCH ESTABLISHMENT OTTAWA REPORT NO. 1271

December 1995 Ottawa

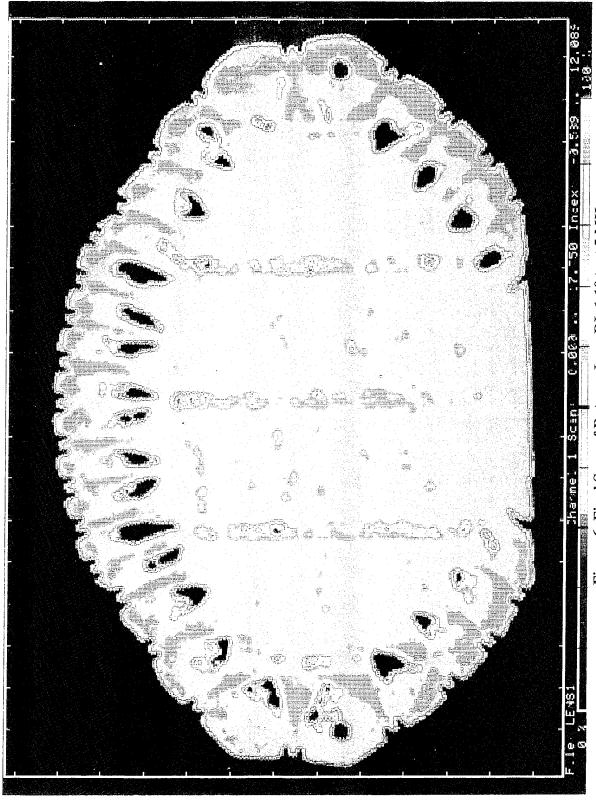
Figure 6 Final Scan of Rotman Lens RL 1.10A at 5 MHz Single Board Construction (Not Spliced)

Figure 6 shows the results of the scan of lens A at 5 MHz. The lens outline can clearly be seen. The vertical lines are evidence of machine work on the aluminum plate prior to assembly. These result from overlap during milling operations, performed to flatten the inner and outer surfaces of the 0.25 inch thick aluminum ground planes. This machine work can be seen on examination of the external surfaces of the lens; however it is the reflection from the internal surfaces that is producing this feature on the display, because the reflections from the outer surfaces have been gated out during the scan analysis. In addition, this was confirmed by the comparison of scans of this lens, both before and after the polishing of its external surfaces to remove the blemishes and surface texture. The blotching is caused by the texture of surface imperfections at one or both of the internal surfaces. By comparing with Figure 2, one can see that dark areas close to the outer edge of the lens lie between the impedance matching transformers. These areas may possibly be air bubbles which were trapped between the adhesive layers, held apart by the adjacent copper foil during manufacture, or adhesive which flowed there while the lenses were being heated under pressure during manufacture. There is also evidence of abnormalities along the vertical milling overlap lines because of areas of increased

density similar to those between the matching transformers.

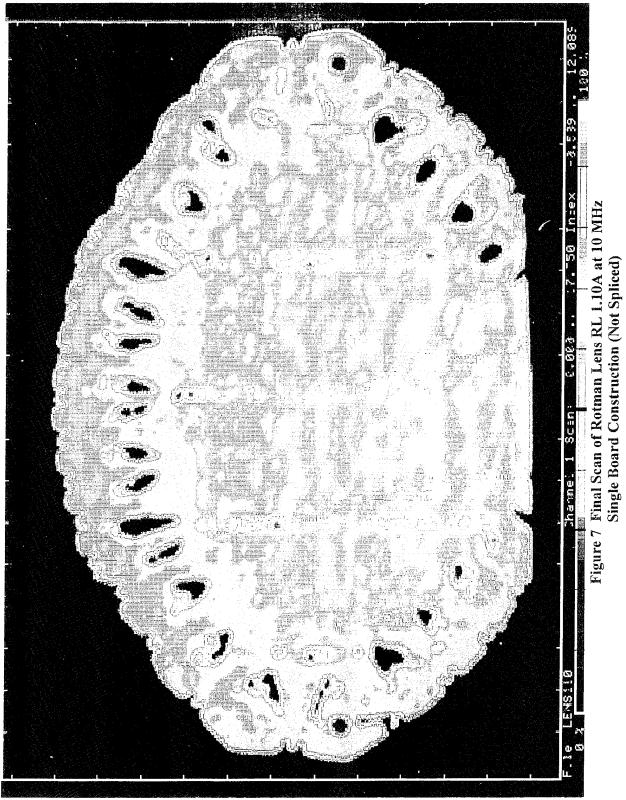
By comparing the data in Figures 6 to 9, using Figure 2 as a guide, it is evident that the primary features, the mounting holes, the possible air gaps between the matching transformers, many of the stronger reflections from internal irregularities, and the milling overlap lines remained unchanged when the transducers were changed and measurements were taken at other frequencies. The "clutter" and overall brightness differences are partly due to the difference in the sensitivity of the sensors. When each of the Rotman lenses was scanned, little new evidence of additional features was seen when the probing frequency was changed. The external surface of lens A was clean, without field probe holes. With the exception of the possible cavities along the milling overlap lines and between the matching transformers, the lens appears to be well bonded and of relatively clean construction.

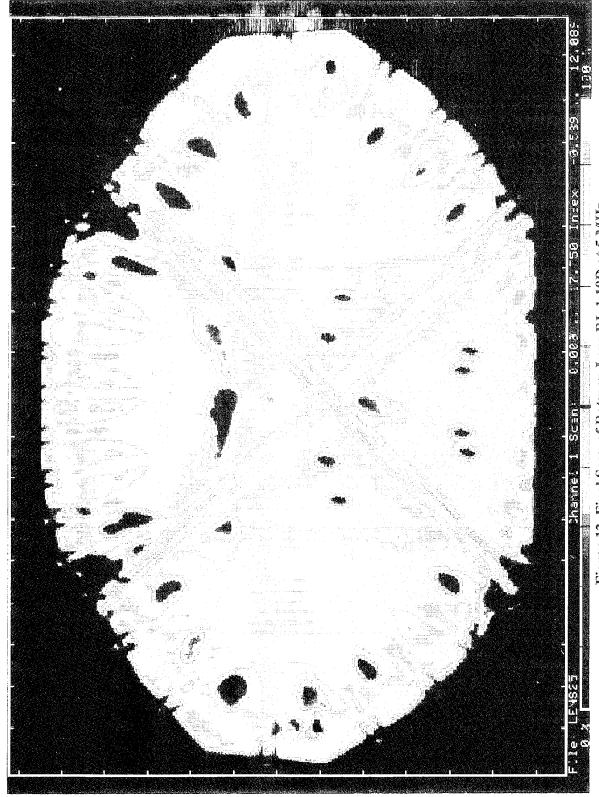
Figure 12 Final Scan of Rotman Lens RL 1.10D at 5 MHz Four Board Construction, Polished

Figure 12 shows the results of the scan of Lens D for 5 MHz. As above, only the one result is shown because of the similarity of the results at the different frequencies. By comparing the scans to Figure 13, the locations of some of the field probe holes can be identified. The holes closest to the beam port side and toward the centre of the lens can be readily located. The holes closest to the antenna ports in each of the sets are difficult to locate because they are hidden by the anomalies at the edge of the lens. The milling overlap lines, vertical in this case, can be seen, but are not dominant. The splices are clearly visible, forming two "X" shaped crosses on each of the scans. It is assumed that the splice in each layer will have the same colour on the C-scan; splice A-B is pink in the scans and splice C-D is red. There is a misalignment between the splices in the upper and lower layers. Several significant suspect areas can be seen in the interior of the lens adjacent to the dielectric splice. and there appears to be some sort of irregularity in the lens at each end of each dielectric splice. Possible cavities between the matching transformers are also evident in the scan of lens D, and the image of each of the two 0.25 inch mounting holes has been merged with the returns from anomalies between adjacent output transformers.

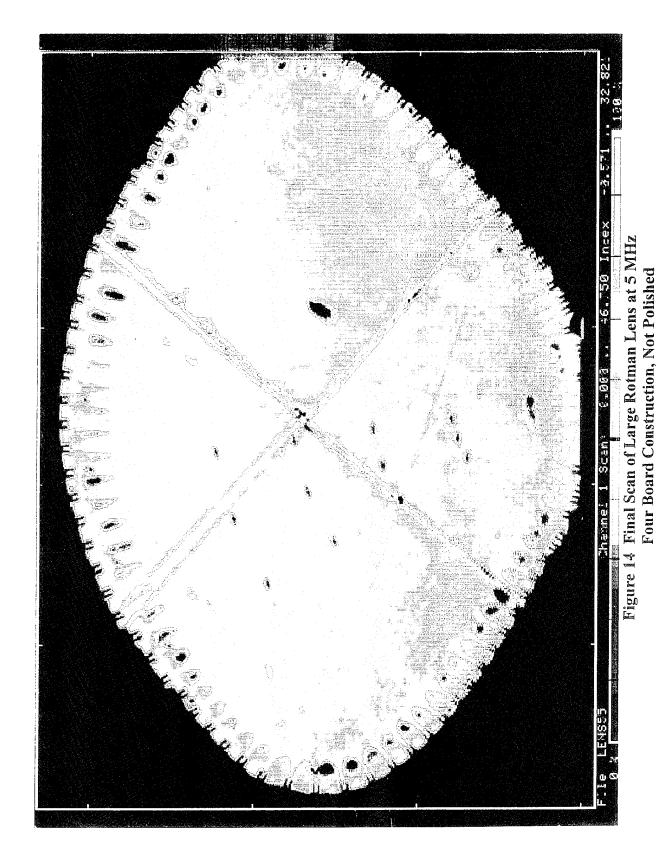
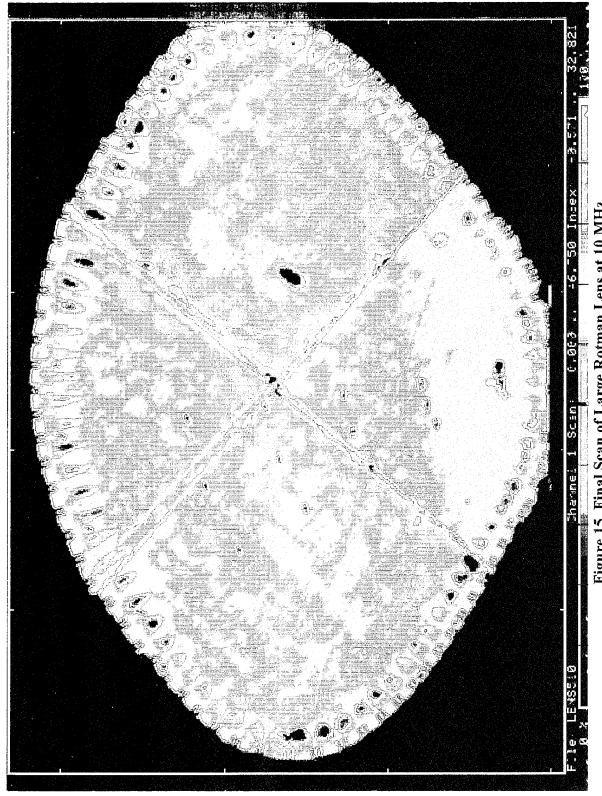
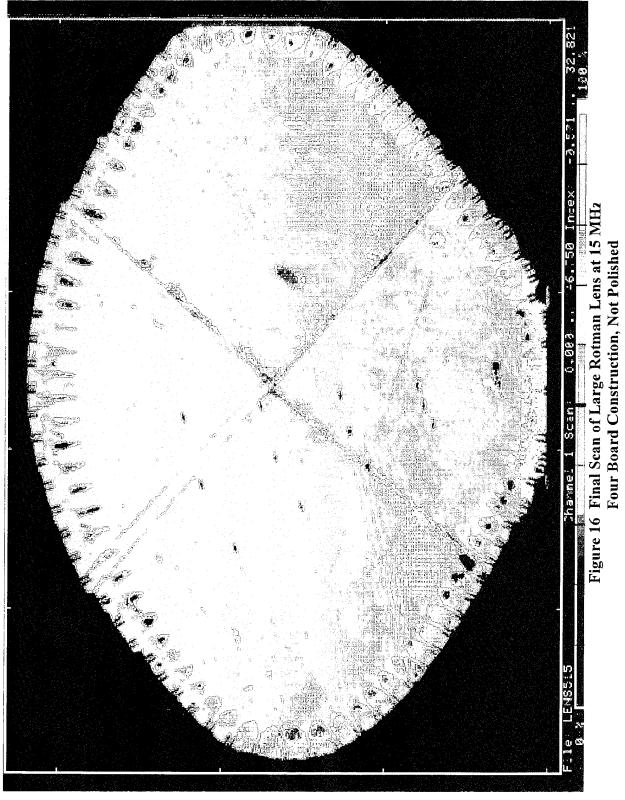
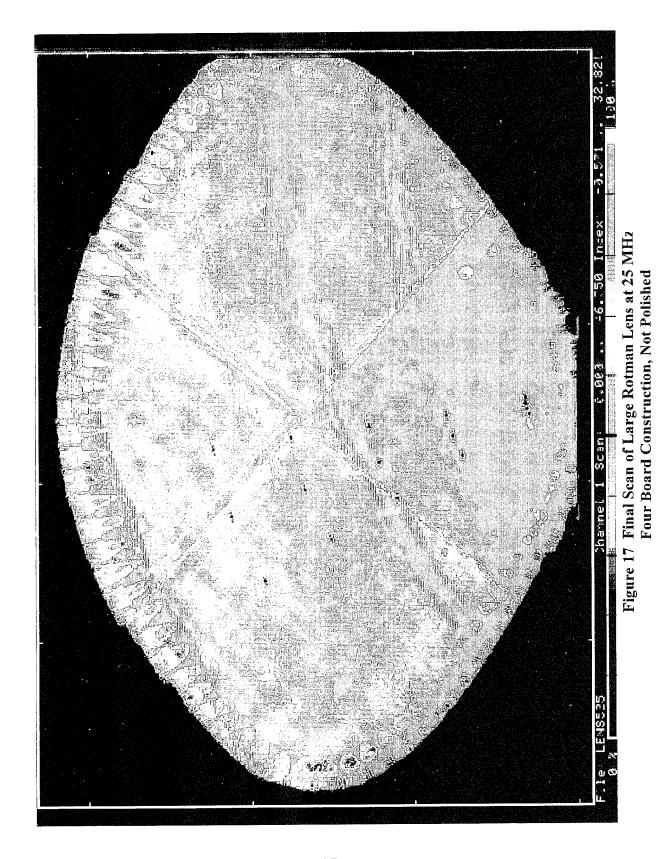
Figure 15 Final Scan of Large Rotman Lens at 10 MHz
Four Board Construction, Not Polished

The scans of the large Rotman lens are in Figures 14 to 17. Significant potential voids can be seen, primarily along the splice lines, between the impedance matching transformers, and in one other area. Eighteen field probe holes were drilled along three lines on each side of the lens, extending from the beam port side to the antenna port side. Those closest to the beam port side are close together, and cannot be resolved. The third hole in the first set lies on a splice line and cannot be resolved, and the furthest holes lie between impedance matching transformers, and can be found by careful inspection due to their characteristic shape. The location of the probe holes and the splices is indicated in Figure 18.

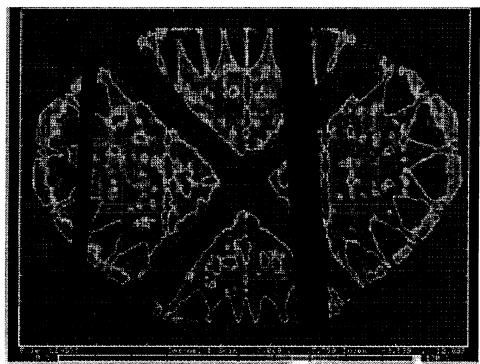
Figure 20 Ultrasonic Scan of Rotman Lens RL 1.10C Showing Cutting Lines for Metallurgical Inspection

Following the verification of the integrity of the scanning process, an additional cut in the lens was made. The locations of the two cuts are shown in Figure 20. The narrower vertical cut on the left was made for the verification of the integrity of the ultrasonic scanning process, described above, and the wider vertical cut on the right was for producing the specimens for examination. The "X" shaped pattern in the centre of the lens is the discontinuity associated with the splice.

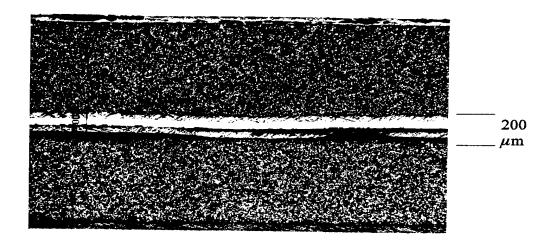
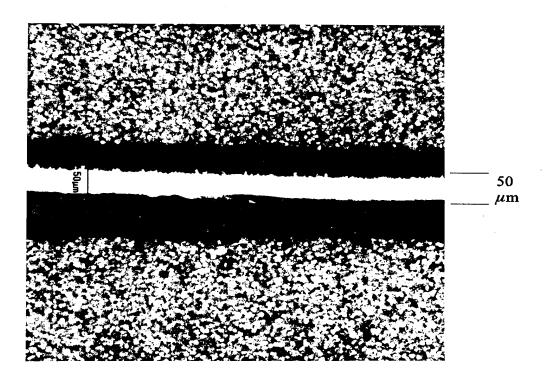
Figure 22 Optical Micrographs of the Cross-Section of Lens C Showing Air Gaps Along the Dielectric/Adhesive Interface

In Figure 22, air gaps can be seen along the interface between the dielectric material and the adhesive. For the most part, the boundary between the adhesive and the copper foil was without air gaps. The air gaps were as wide as 30 microns and their locations matched the locations of the flaws on the C-scans. It is unlikely that these gaps were generated during the cutting or polishing processes, since other regions of the same specimen were good, similar to those shown in Figure 21.

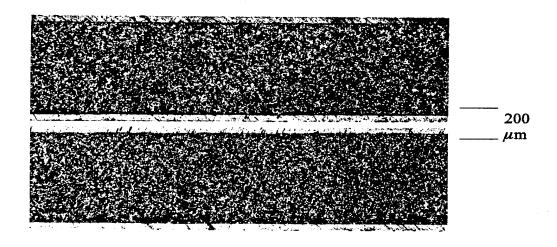
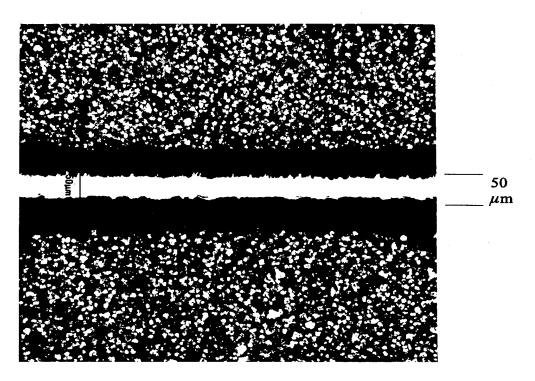
Figure 23 Optical Micrographs of the Cross-Section of Lens C Showing Disbond Between the Dielectric Material and the Adhesive

The microscopic inspection of one of the lenses has confirmed the presence of air gaps and disbond within the sectioned lens. Because of the similarities between the ultrasonic scans of that lens and those of the others, it is implied that the remaining lenses also contain similar defects. It is not known to what extent the presence of these flaws has degraded the RF performance of the lenses, and this was not able to be evaluated at this time.

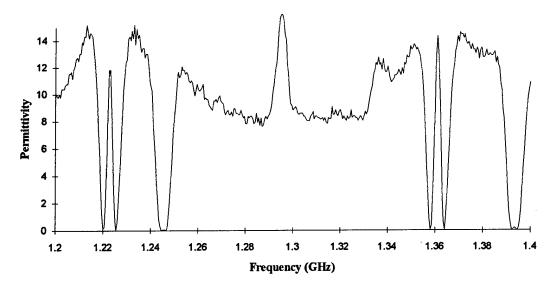
Figure 32 Permittivity Based on Delay Data for 1 Ohm Lines Fabricated by Buckbee-Mears, St. Paul, MN

The permittivity of the dielectric obtained through the analysis of the delay data from 30 and 1 ohm lines has also been obtained. It is shown in Figures 30 to 33. Structures were fabricated by Buckbee-Mears, St. Paul, MN, and CMR, Montreal, PQ. There is some consistency in the values obtained. For 50 ohm lines, the average permittivity is the highest, dropping somewhat for the 30 ohm lines, and reaching its lowest value for the 1 ohm lines. The two curves for 30 ohm lines show local maximum values near 1.3 GHz, and minimum values near 1.37 GHz. There seems to be a problem with the 1 ohm transmission line structure made by Buckbee-Mears. It

has a number of deviations from the average. In an attempt to investigate these, the measurements were repeated with different cables and cables of different lengths. It is possibly caused by interactions at the connector, or inadequate bonding of the structure. Spar Aerospace also reported this problem in their contract report. (11)
